Community Consultation – Future of HOOE VILLAGE HALL

5.17 Sheppard Survey Further Analysis

This document provides recent context to the 4.2 Sheppard Survey report from 17 Sep 2019. See document 5.17a, a reproduction of the original 4.2 Sheppard Survey report colour coded using the following criteria by Cllr Leonard on 12th June 2024.

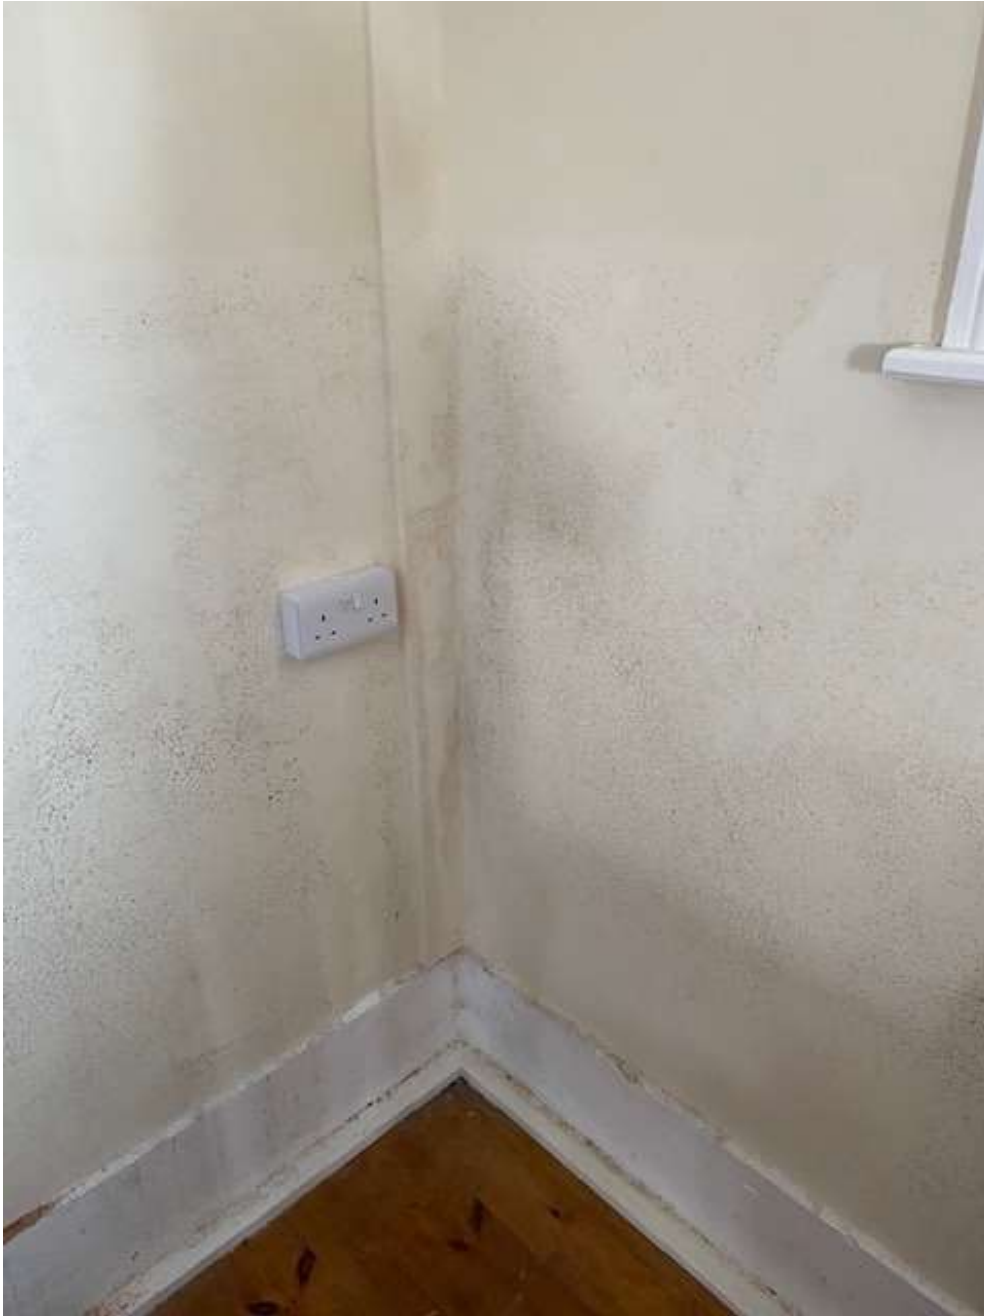
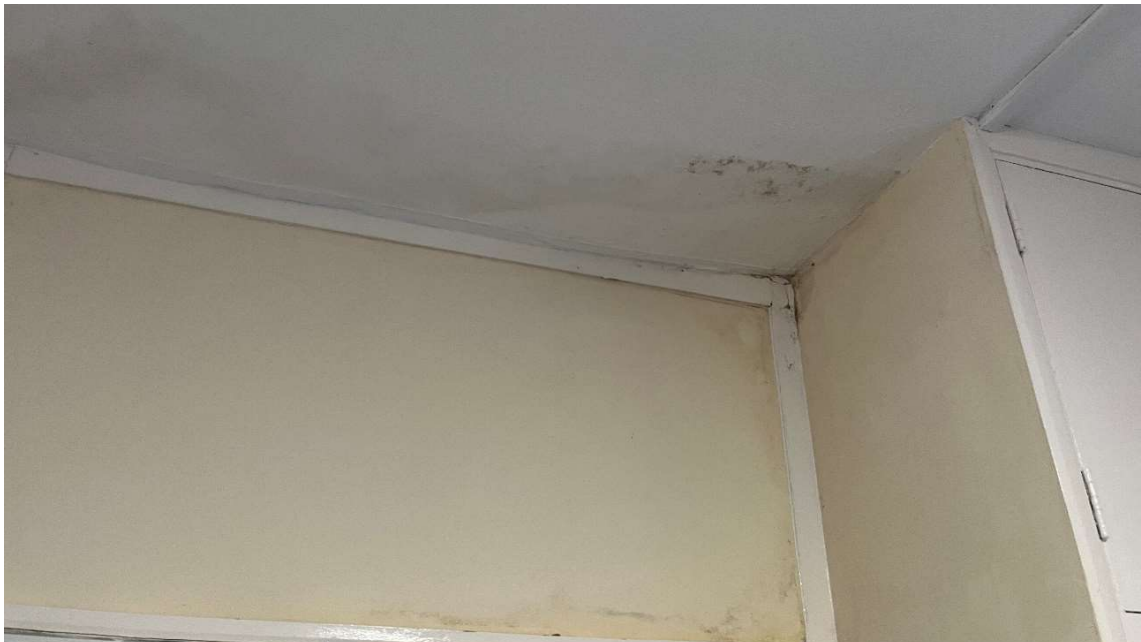
Up to date photos – Inside Mould

No photos were taken at the height of the black mould inside the hall all around up to a height of 6 feet in places during January/February – however we know the cause of this and the history and can decide if necessary to improve ventilation and heating in winter. The mould does clean off and stays away during warmer months. General condition of internal walls regarding damp or rising damp is not actually known but there is strong evidence of internal leaks resulting from crack roof covering between main hall and rear-extension, water is damaging ceiling and inside cupboard in rear extension.
